# Fracture Analysis of an Embrittled Low Alloy Steel Rotor Blade from an Operating Steam Turbine

A public utility company had several steam turbine electrical generation systems that had been in service for nearly three decades. A catastrophic brittle failure occurred in the rotor section of one of the turbines. Auger Electron Spectroscopy (AES) analysis with a PHI Scanning Auger Nanoprobe examined specimens removed from the failed rotor to ascertain the cause of the failure and to examine the possibility of recovering similar rotors that remained in service.

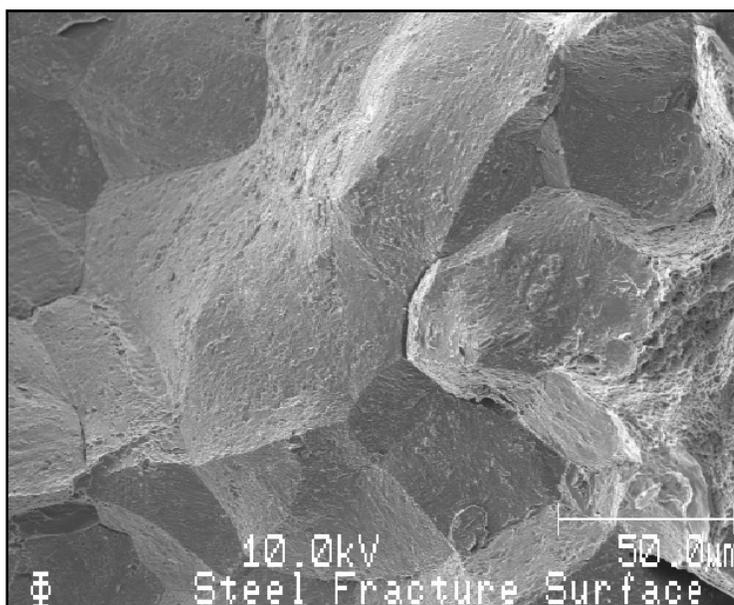
Samples were taken from the failed rotor and analyzed with AES using a PHI 680 scanning Auger nanoprobe. The samples were cooled *in vacuo* with liquid nitrogen to enhance brittle fracture, then fractured at a pressure of  $1.2 \times 10^{-10}$  torr to prevent contamination of the newly-exposed surfaces. AES analysis revealed predominantly brittle intergranular fractures, as shown in the secondary electron image. Analysis results also indicated that some ductile rupture was present and that the grain boundary surfaces were not smooth, but highly textured.

Secondary electron image of the rotor blade showing the brittle fracture surface.

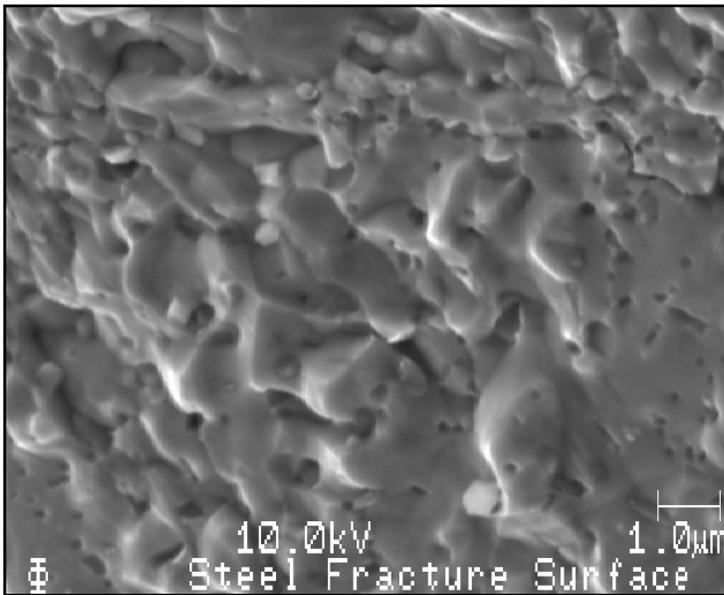
High magnification secondary electron image of the fractured rotor blade

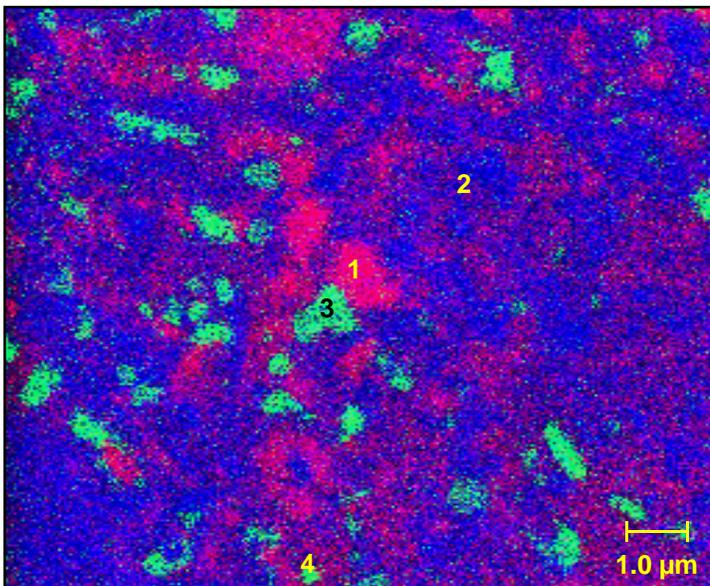
Color overlay of Auger elemental images:  
Blue = Fe, Red = Sb, Green = Cr.

At high magnification, the texture of the grain boundary surface is very evident. Auger analysis of the area shown detected alloying elements Fe, Cr, Ni and C and impurity elements S and Sb. The detection limits for Auger are about 1 part-per-thousand (ppt) under optimum conditions and were greater than 1ppt under the conditions used for this experiment. S and Sb were present in the bulk at only ppm levels, suggesting grain boundary segregation of these elements. Ion sputter etching to remove about 50 Å of material from the grain boundaries eliminated all traces of Sb. Some S remained, providing good physical evidence of Sb segregation to the grain boundaries.

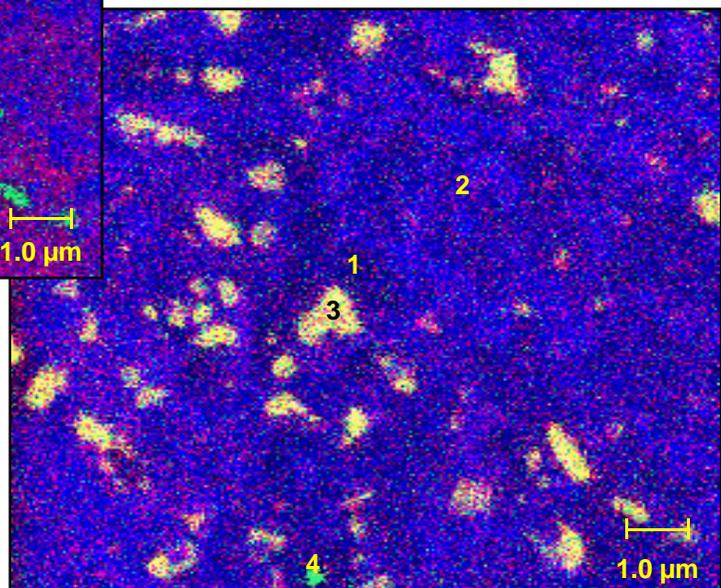
Color overlay of Auger elemental images:  
Blue = Fe, Red = C, Green = Cr, Yellow = Cr + C.

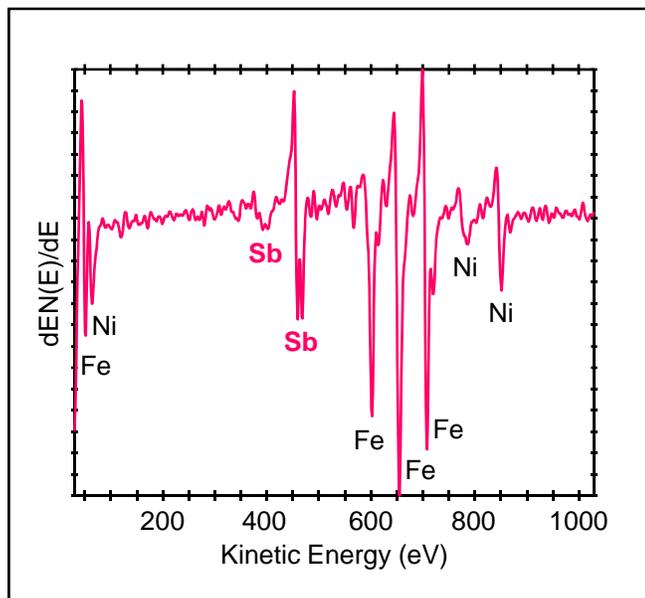
Point 1: high in Sb and Ni

The analysis shows clear evidence for segregation of Sb to the grain boundaries. Individual elements are not uniformly distributed across the grain boundary surface, but are localized. Point 1 is an area that is high in Sb and also quite high in Ni, an alloying element. This cosegregation is consistent with temper embrittlement.

The segregation of Sb and Ni to the grain boundaries of the low-alloy steel rotor blade was shown to be the primary cause of the catastrophic failure. It is known that temper embrittlement is a reversible effect. The public utility is undertaking heat-treating experiments to determine if the non-failed rotors can be salvaged by reversing the segregation. If this is possible, it will save several million dollars for each turbine.

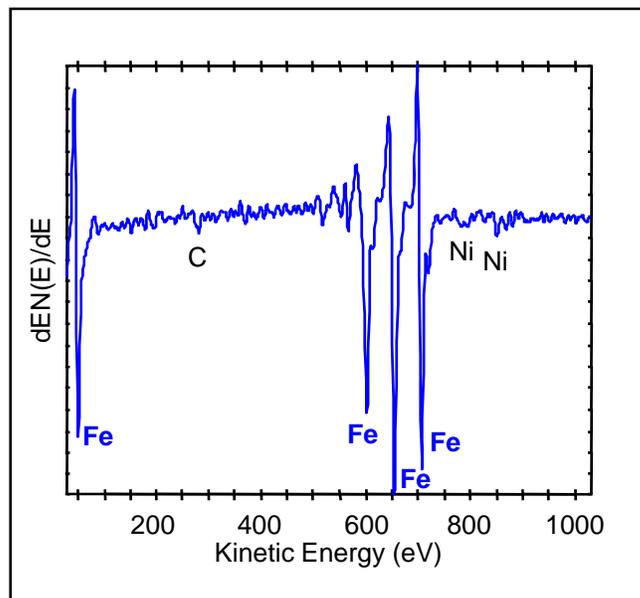
Point 2: steel matrix

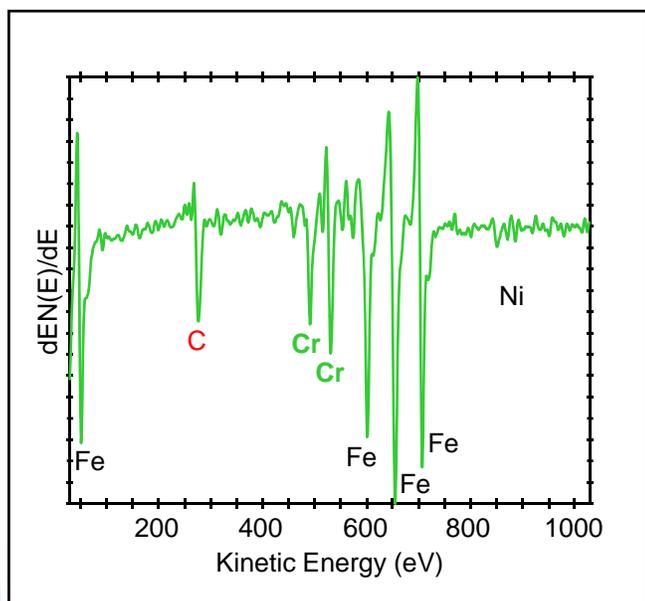
Point 3: high in Cr and C

From these analysis results, it can be surmised that Sb is a primary cause of the observed embrittlement. Point 3 is high in Cr and C, and the C peak shape indicates Chromium-Carbide (CrC). At Point 4, the Cr is associated with S, most likely indicating Chromium-Sulfide (CrS). The CrC and CrS are very small grain boundary precipitates or inclusions that may have little effect on the brittle nature of the sample. This is important, because a general segregation of S to the grain boundaries where it is not chemically bound into a sulfide can also cause embrittlement.

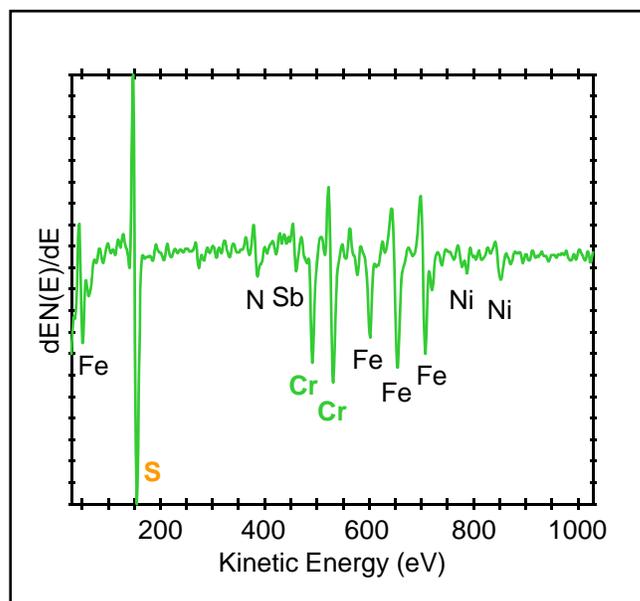
Point 4: high in Cr and S

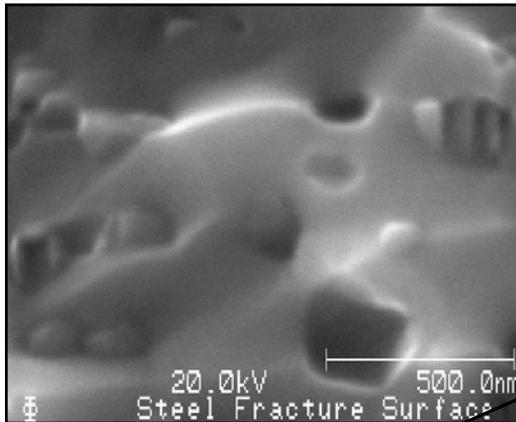
Secondary electron image of rotor blade at higher magnification showing inclusions

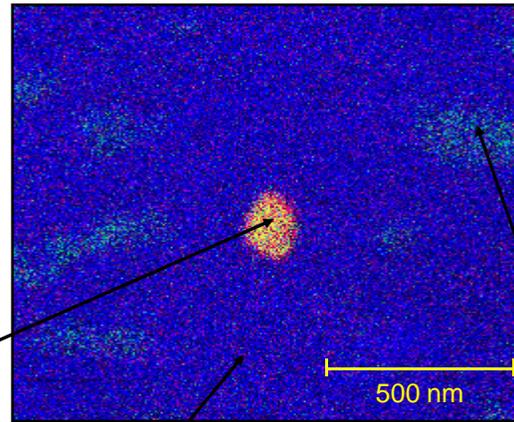
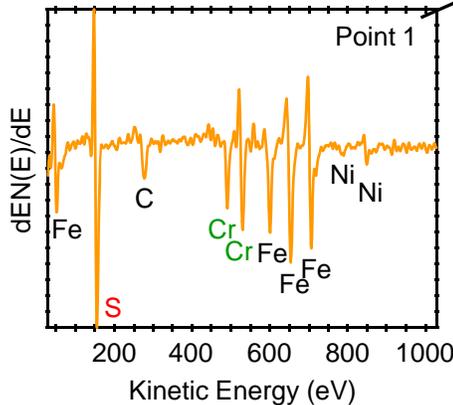
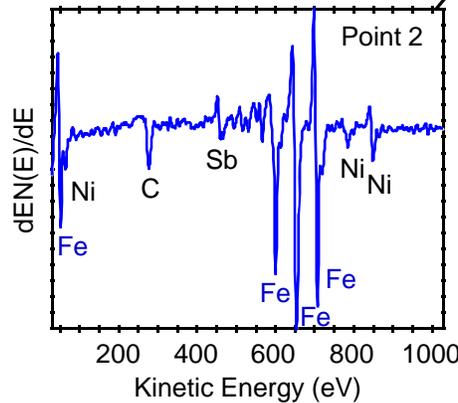
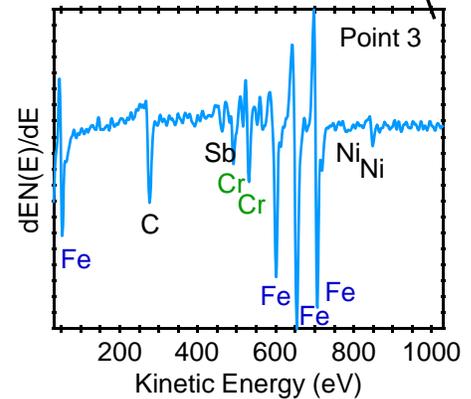
Color overlay of Auger elemental images: Blue = Fe, Red = S, Green = Cr, Yellow = Cr + S

These discrete inclusions lend themselves to further analysis at higher magnification. An area with several inclusions was examined at very high magnification and analyzed with a similar sequence. The secondary electron image, as well as the color overlay Auger elemental maps and Auger point spectra detail a very small, 1000 Å diameter CrS inclusion (Point 1), general Sb and Ni segregation to a smooth area of the grain boundary (Point 2), and a CrC inclusion (Point 3).
